Fire Protection Engineering Department Worcester Polytechnic Institute

Turf House Fire Safety

Full WPI Report for Hurstwic

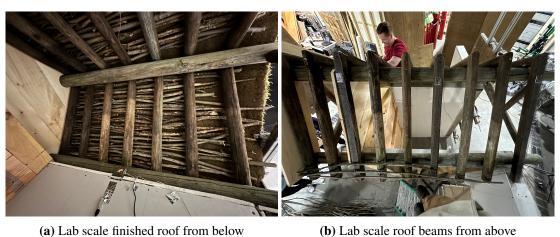
Figure 10: Lab scale roof structure

(b) Lab scale roof beams from above

In addition to the fire spreading through the door, the fire propagation along the roof structure was of particular interest to this study. For this reason, the roof was framed using reclaimed eastern red cedar fence rails, with a diameter of about 15 cm. The frame was covered with small diameter sticks, approx 1 cm, that were arranged perpendicular to the joists and served as support for the turf mats used as roof shingles, as shown in Fig. 10a. In accordance with what is known about Viking-age construction, the structural members under the ceiling were left exposed. The roof frame was screwed directly into the top of the corridor studs. Four layers of overlapping locally sourced sod were used as a stand-in for turf.
